⁽⁶⁾
METALLURGICAL CHANGES IN THE HIGH
TEMPERATURE FRETTING OF Ni and Ti
ALLOYS

⁽⁹⁾ Final Technical Report

⁽¹⁰⁾ R.B. Waterhouse and M.M. Hamdy

⁽¹¹⁾ February 1979

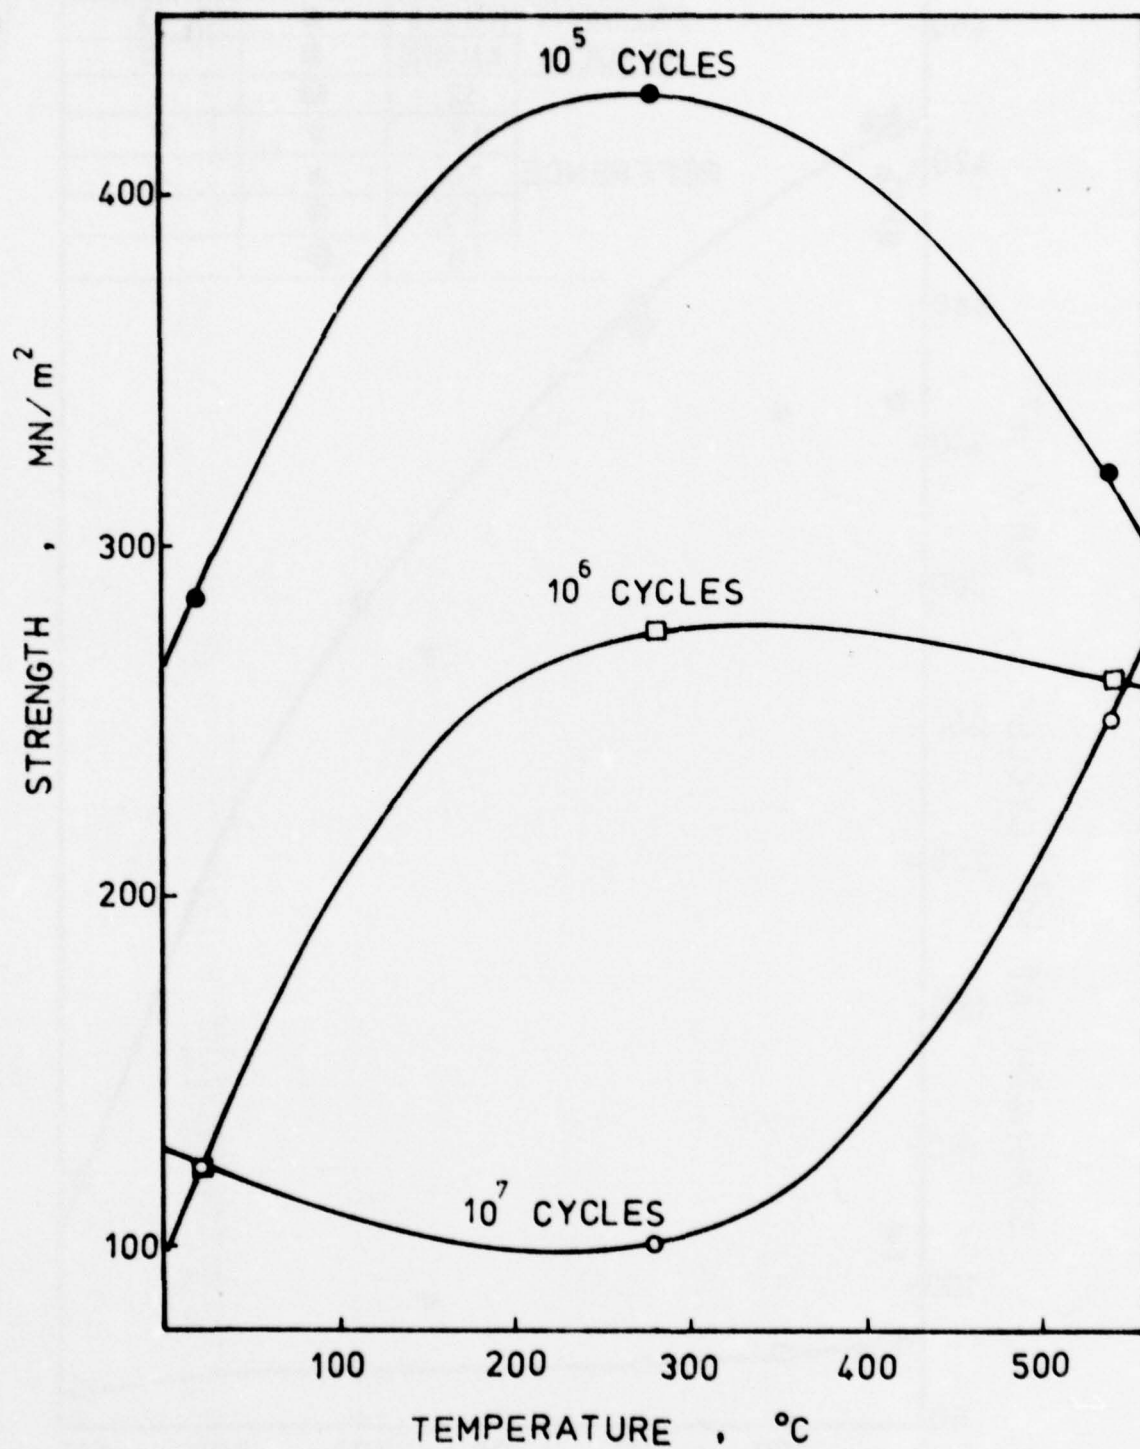
FIG. 54 EFFECT OF TEMPERATURE ON THE FRETTING FATIGUE STRENGTH OF AGED INCONEL ALLOY 718.

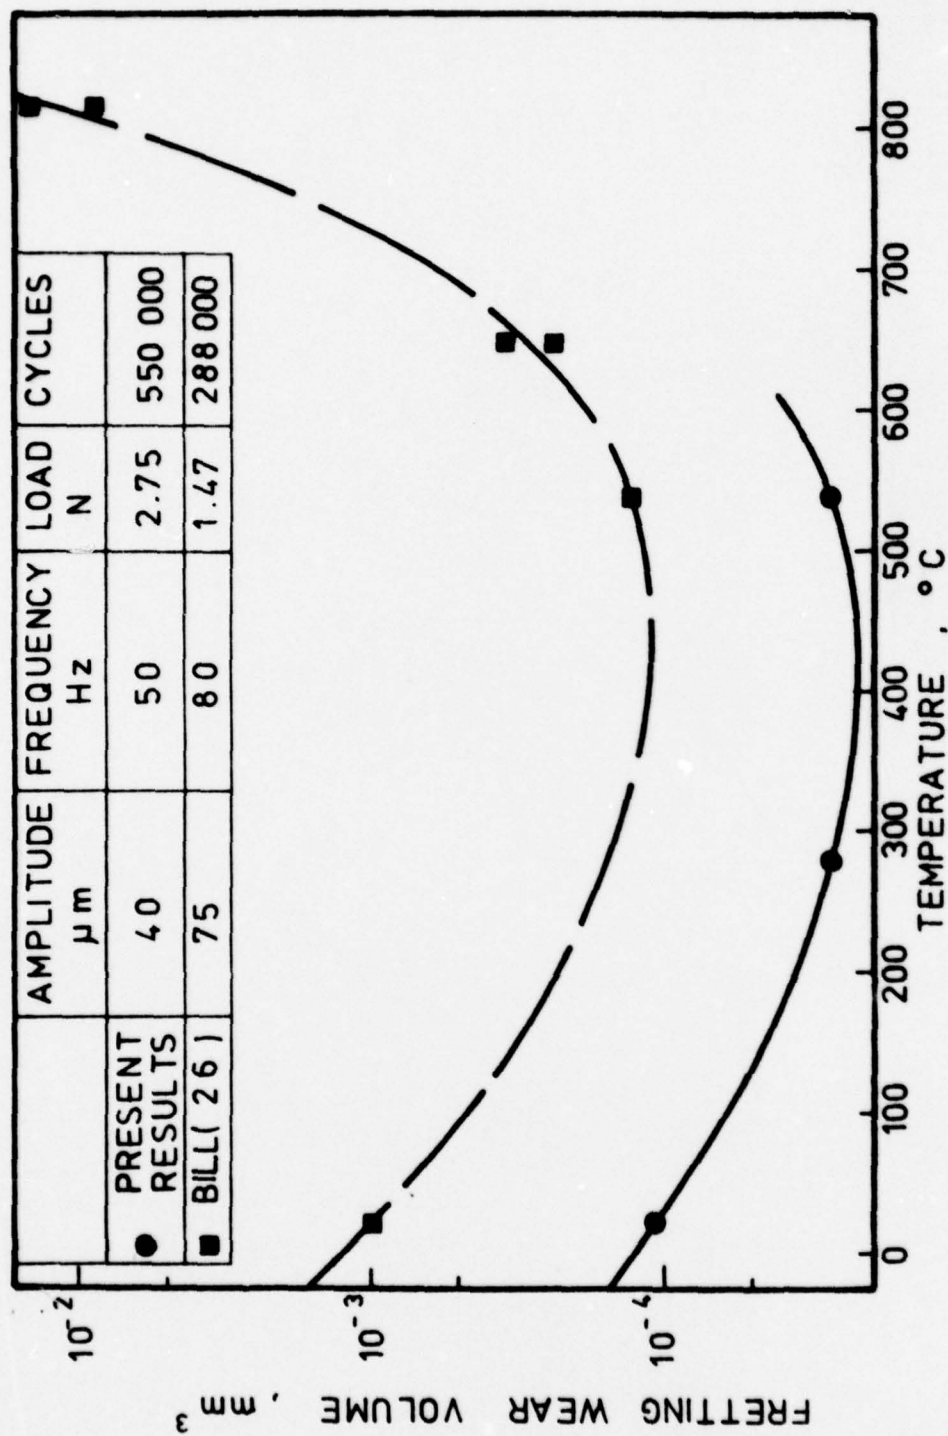
Fig. (55) TEMPERATURE EFFECT ON FRETTING WEAR VOLUME OF NI-BASE ALLOYS.

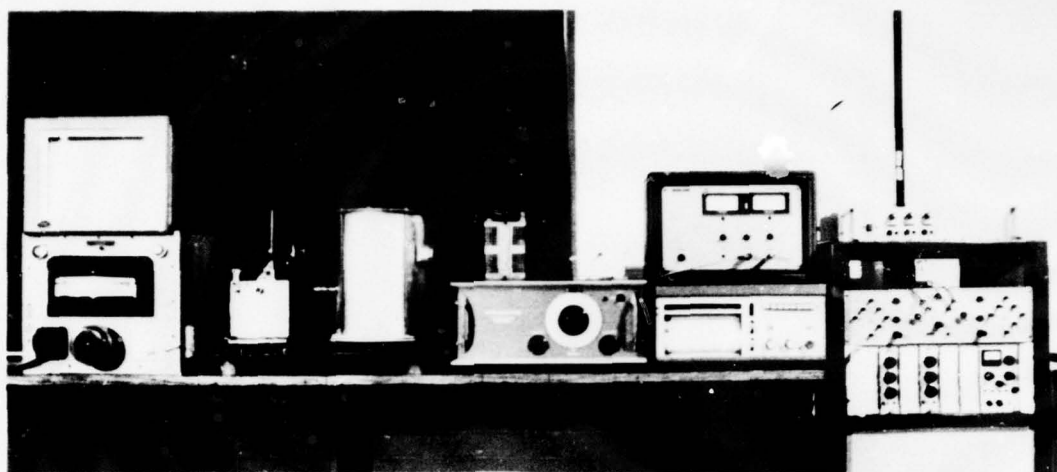
Plate 7 Fretting wear test arrangement.

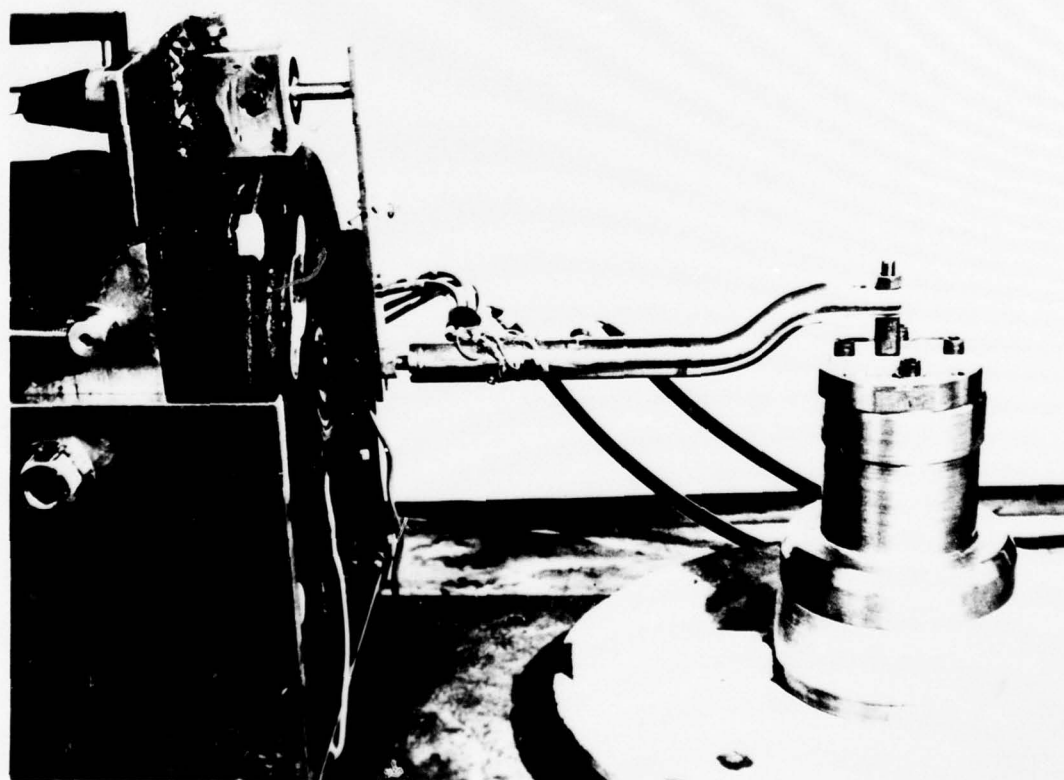
Plate 8 Oscillating movement system.

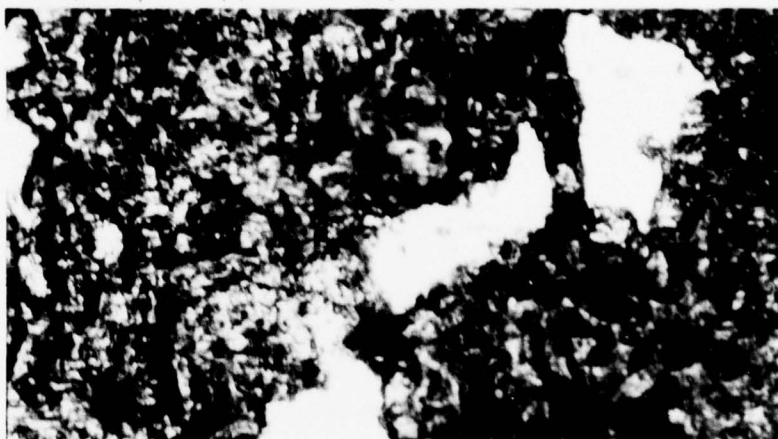
Plate 19

Optical picture of Inconel 718
 20°C, 40 μm slip, 10^6 cycles.
